ALABAMA DEPARTMENT OF ENVIRONMENTAL MANAGEMENT
 WATER DIVISION – INDUSTRIAL AND MUNICIPAL SECTIONS
NONCOMPLIANCE NOTIFICATION FORM

PERMITTEE NAME: Leeds WWTP PERMIT NO: AL0067067

FACILITY LOCATION: 800 Helen Street Leeds, AL (Jefferson County)

DMR REPORTING PERIOD: December 2014

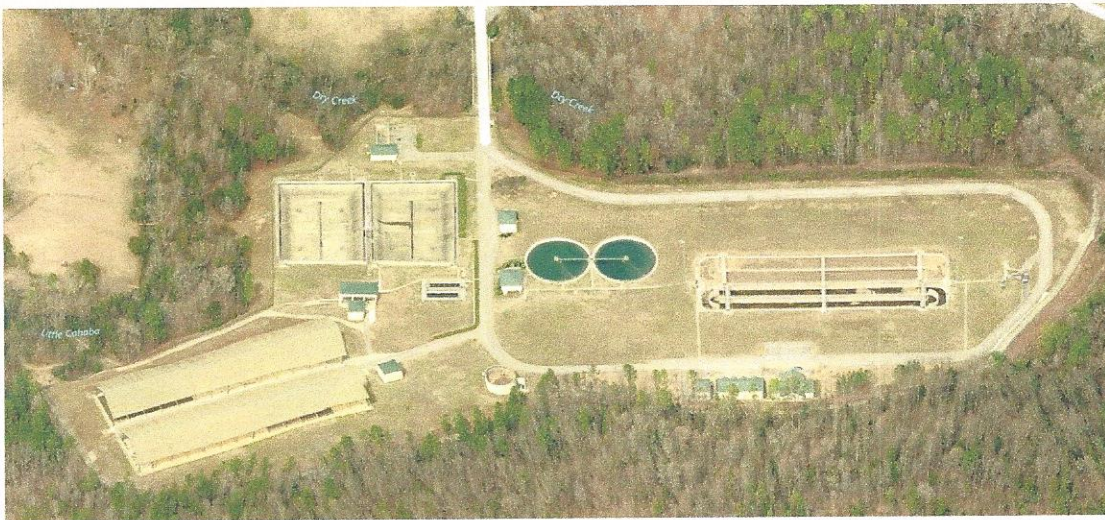
The weekly and monthly average ammonia concentration violations were caused by a biological upset in the activated sludge process. The loading limits were not exceeded. The cause of the upset has been identified as equipment failure coupled with neglect-of-duty on the part of two operational staff and is further described below. The WWTP is staffed with certified WWTP operators 10-hours per day seven days per week.

The WWTP was constructed with two 2.5 MG aeration basins and only one is typically operated as shown in photo below. The active aeration basin (basin #2) experienced mechanical failures on two of the four brush rotors, so at approximately 8:30 a.m. Wednesday December 10, 2014, flow was transferred to basin #1. On Wednesday December 10, 2014, the instrumentation staff worked on the dissolved oxygen (D.O.) probe but could not complete the calibration because basin #1 was not yet full of water. The WWTP operational staff was instructed to monitor the system to make sure it operated correctly when it came into contact with the water because the brush rotor aerators are automatically controlled (turned on/off) by D.O. levels that are continuously monitored. The D.O. probe consistently read a false level between 1.5-1.6 mg/l which is below the set-point that turns on the rotors. The brush rotors did not operate from December 10, 2014 until 8:42 a.m. on December 15, 2014 when they were manually turned on by the Monday shift supervisor. The operators who worked between Thursday and Sunday failed to recognize the rotors did not run even though they recorded zero run hours on their daily log sheets. The operators were confused because SCADA showed animation with the aerators running. During this five day period, the aerobic nitrifying bacteria were stressed by the anaerobic conditions that had developed in basin #1. By Monday December 15, 2014, the basin had developed an odor and had settled solids because the submersible mixers do not provide complete mixing without the rotors in service.

Upon discovery Monday morning December 15, 2014, the WWTP Shift Supervisor immediately started effort to restore the aerobic biology. All four rotors were turned on manually. Because the rotors in basin #1 had not been exercised under load for almost two years while basin #2 was in service, rotor motors 1-1 and 1-2 failed when loaded and the circuit breaker for rotor 1-1 was found to be defective. With two of the four rotors out of service on basin #1, adequate D.O. was not able to be supplied to quickly overcome the anaerobic conditions. Two motors from basin #2 were relocated to basin #1 on December 18, 2014 and the circuit breaker was replaced the next day.

By December 19, 2015 all four rotors and all mixers were running continuously. Effluent samples were collected for the 17th-21st.
